Sullivan County Cooperative Extension Service

**24 Main Street
Newport, NH 03773**

Energy Audit Report

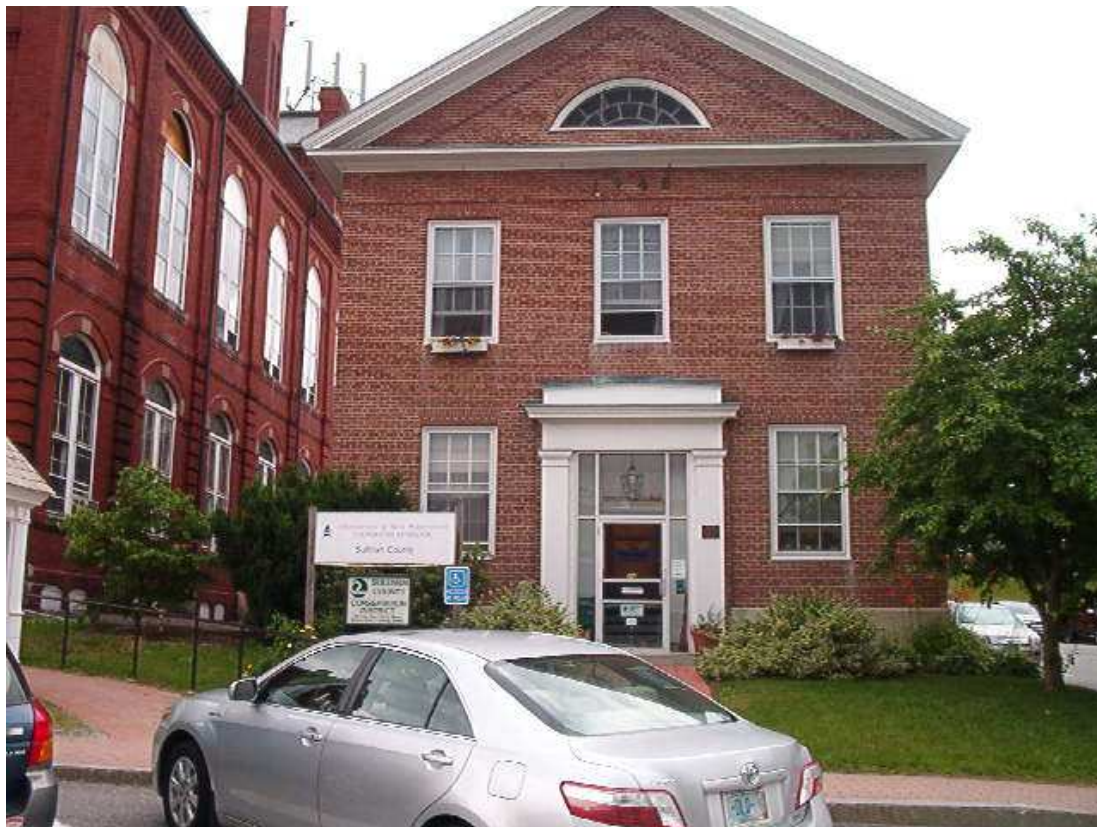
West facing entry way view

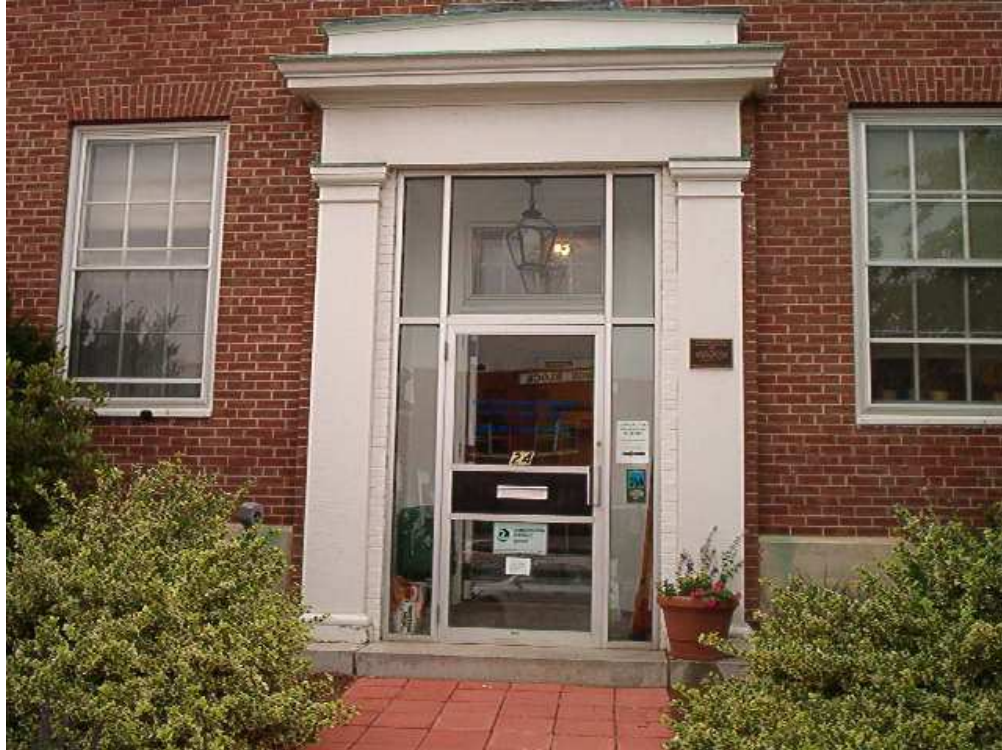
Front door with added aluminum frame and glass storm door

First Floor: front entry way door has had a commercial metal framed door and window added as a storm door/airlock entry. This entry is small and not handicapped accessible, but a ground level rear door is available for access to the first floor offices. No handicap access is available to the second floor, as only one stairwell services the building. The upper glass panel in the metal framed door is missing its top cross channel to seal and hold the glass into the door frame. The door also does not seal evenly around the metal frame. The original wood entry door is oversized and the weather stripping and sweep should be replaced. Inside the building, on the wall under the alarm panel some conduit and wire mould path ways are open and should be closed off with fire stop caulk. At the ground floor entrances the exterior surface has been refinished and some of the building wood trim work is in contact with the soil, providing a path for moisture and insect entry to the building.

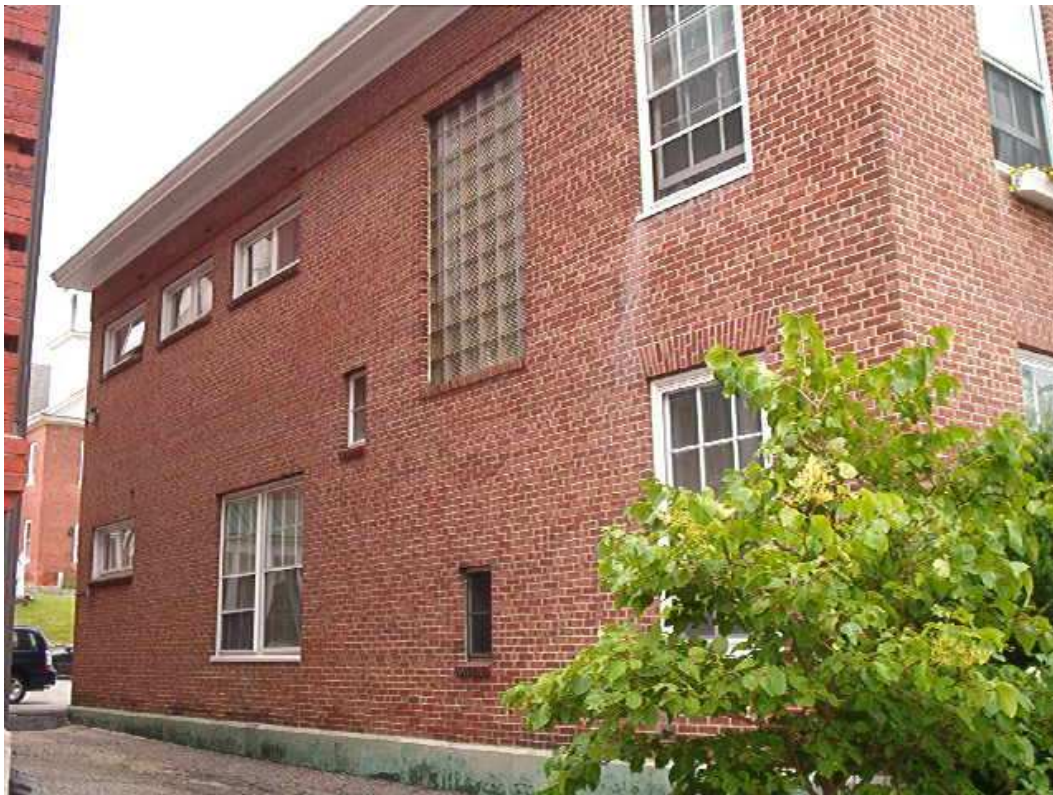
North Side of building adjacent to the County Court House

Note: Glass block windows in stairwell, replaced awning windows on NE end.

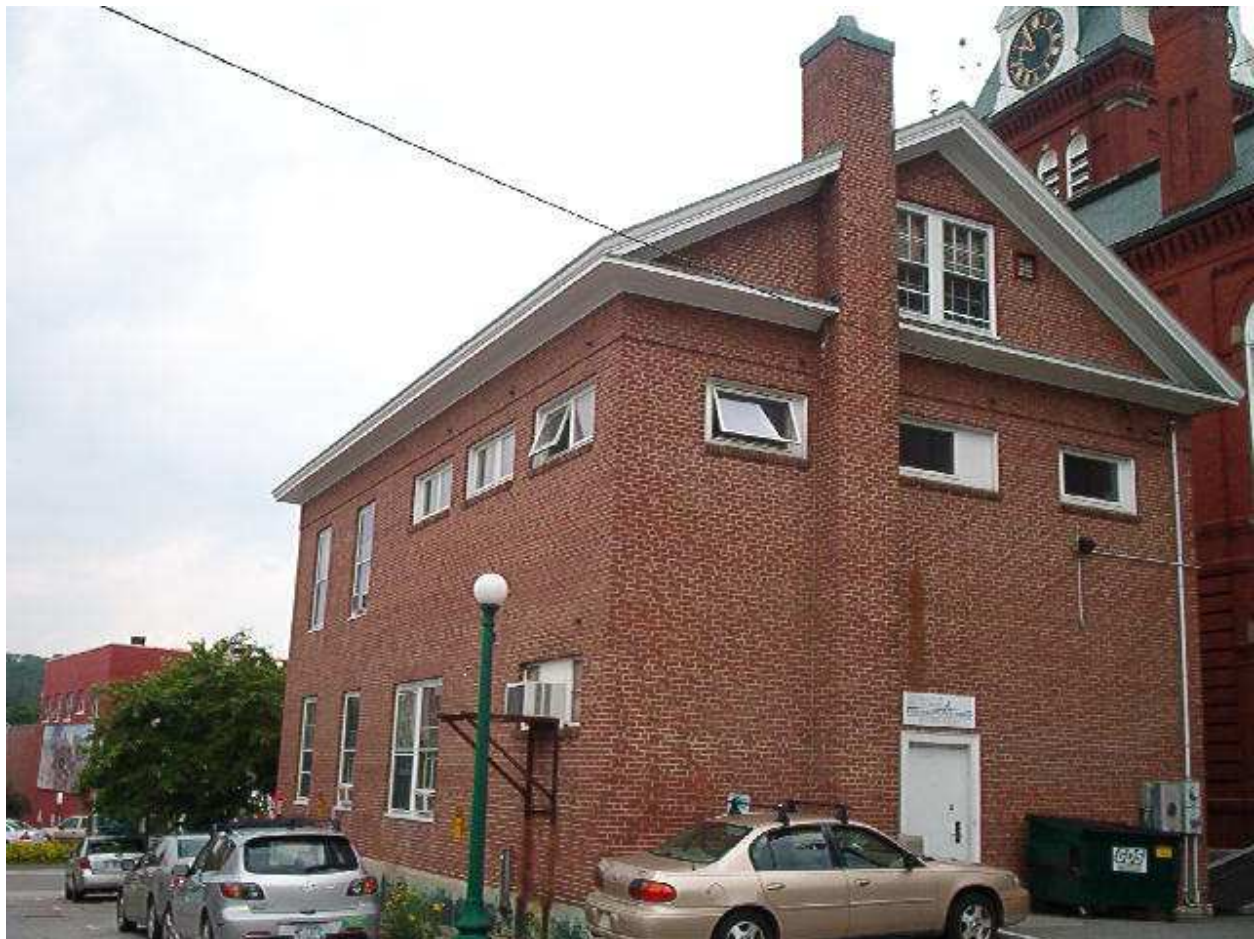
East side of building with back door and chimney for the oil fired Boiler. The South side faces the alley, note replaced awning windows and four window air conditioning units in windows.

locally controlled in each office space. One of the south side A/C units is supported on an external steel framework that is an eyesore and not historically accurate. In defense of the current window mounted units, they all appear to have been replaced with models that are up to date regarding energy efficiency in window units. Split ductless systems are about 3 times more energy efficient, and this climate zone requires limited air conditioning but this is an exceptionally warm summer.

Air Conditioning: The building has six window air conditioners for spot cooling of office area. This method of cooling is not the most energy efficient and has a negative impact on the buildings historical look. The upgrade solution would be to install ductless split air conditioning units or variable refrigerant flow (VRF) with the condenser located outside, between buildings and wall mounted evaporator units
